EES Gymnasium Roof Replacement Building Committee  
Eastford Elementary School  
Thursday  
August 2, 2018  
Minutes

August 8, 2018  
Eastford Elementary School Roof Replacement

Re: Proposed Substitution - Roof Railing

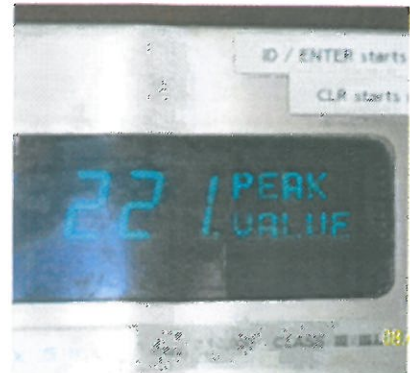
At the point of pull, the top rail deflected, due to tipping, a total of 16 inches with no slippage of the base along the test surface. Fig. 8 shows the amount of test pull to be 221 pounds. Upon release of the test pull, the system was shown to have remained its' original position/location.

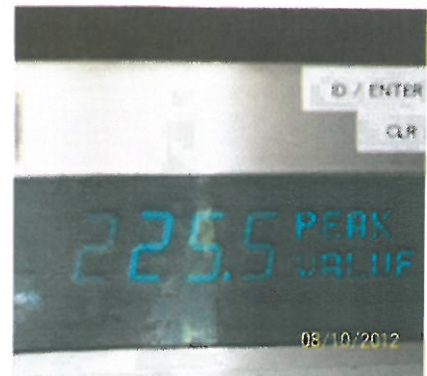
At the point of pull, the top rail deflected, due to tipping, a total of 16 inches with no slippage of the base along the test surface. Fig. 11 shows the amount of test pull to be 225.5 pounds. Upon release of the test pull, the system was shown to have remained in its' original position/location.

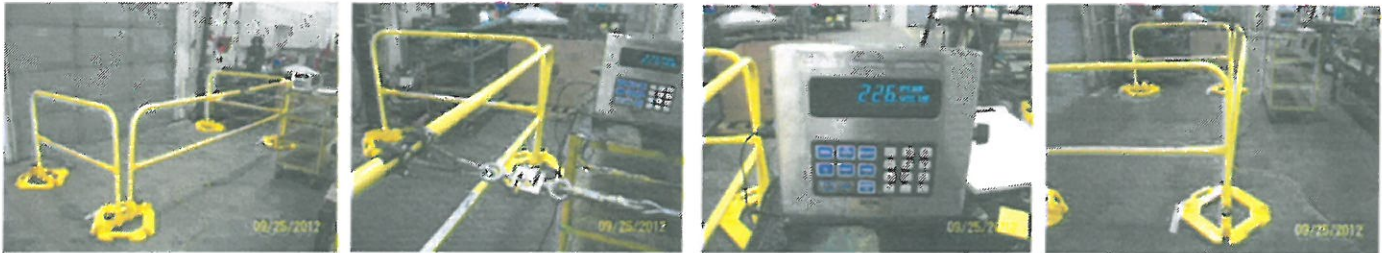
10 Foot Rail Test.

Each Rail was tested to a minimum of 113% of the required load with no failure of any component. A maximum tipping of the bases of 1.5" as measured from the back lower edge of base to the floor was identical for each configuration.

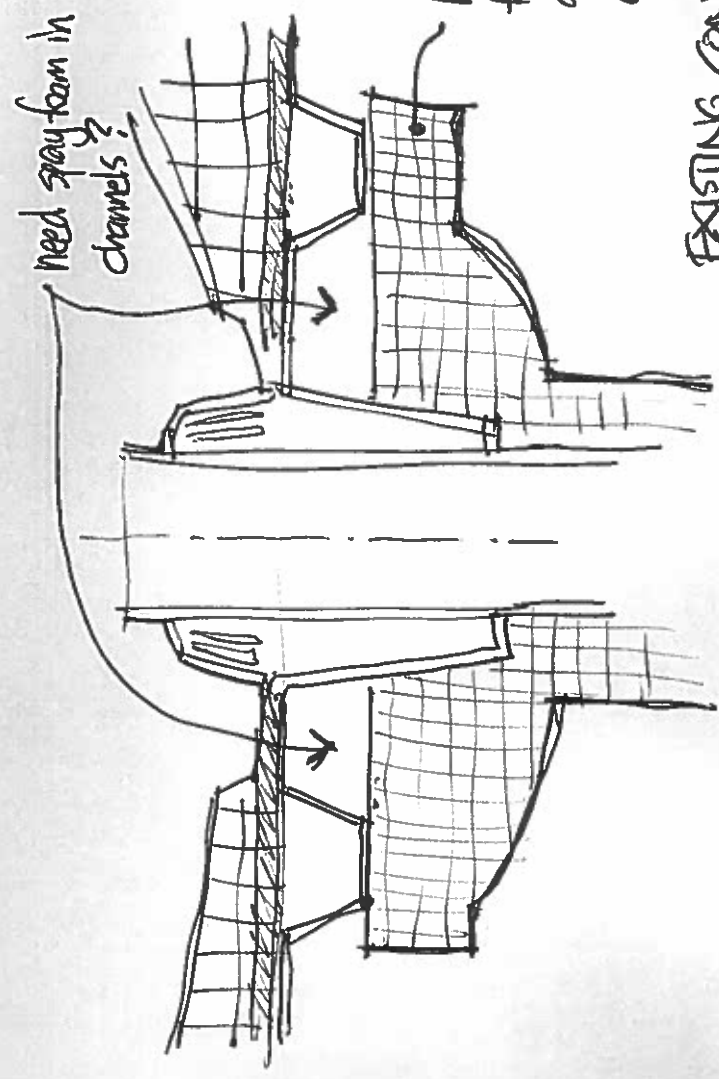
EXISTING CONDITION OBSERVED BY COMMITTEE ON 9/2/12

18" rand disk with flat upper surface, but not apparently sealed at roof deck configurations?

A lengthy conversation ensued after the conference call with you last Thursday night. Committee members reviewed the plans and took a picture of their area of concern.

The final plans had been appropriately modified to address the insulation concern brought up upon reviewing an earlier draft. Your comments on Thursday didn't seem to indicate that the contractor was held accountable for sticking with the plan.

Thank you for sending the photo of the potential area of concern. In reviewing the photo you sent, the roof drainage pipe is insulated and the drain bowl is insulated to the underside of the deck. That is the standard detail for a roof drain installation. When the roofing contractor schedules the warranty and punch list visit, we can have them stuff mineral batt insulation in between the flutes of the metal decking at the roof drain locations.

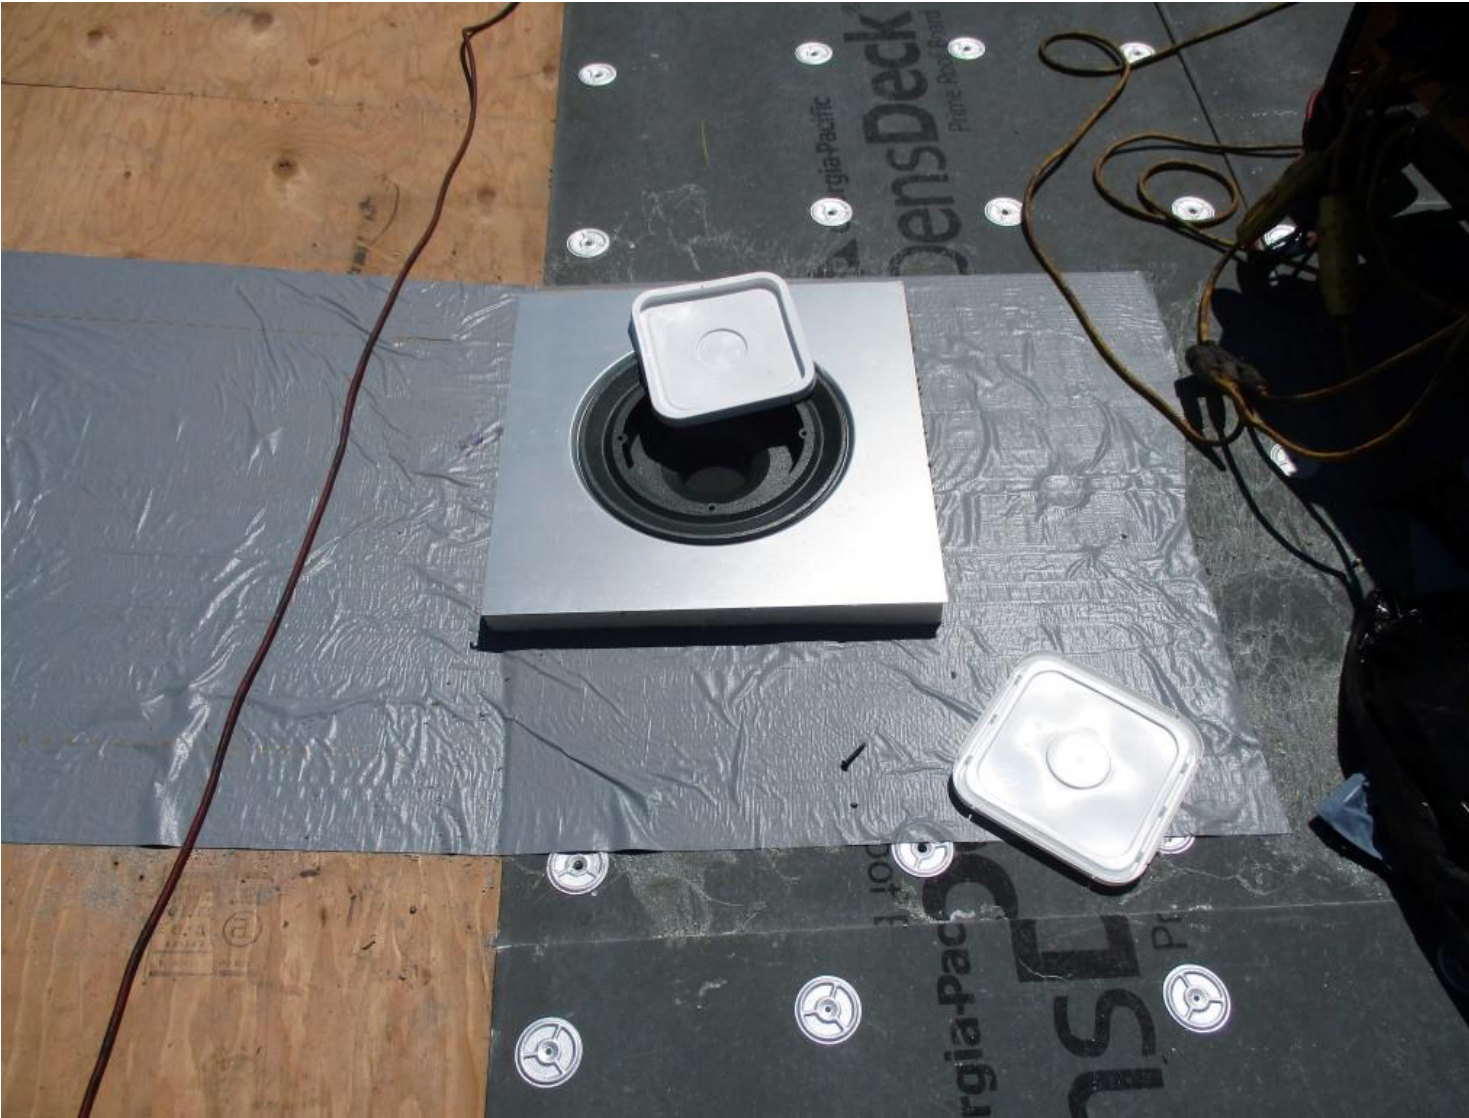
I've attached a photo of when the roofing contractor and the plumber were roughing in the roof drain assembly. In the photo you can see that insulation is installed beneath and around the roof drain. There could have been some misinterpretation during the call when we were discussing insulation at the roof drains. I will be reaching out to the roofing contractor to get a status update this morning. In meantime, please feel free to email or call if you have any questions or concerns.
